FLIGHT SERVICE EVALUATION OF COMPOSITE HELICOPTER COMPONENTS

Final Report

FEBRUARY 1981 through NOVEMBER 1990

SIKORSKY AIRCRAFT
DIVISION OF UNITED TECHNOLOGIES CORPORATION
Stratford, Connecticut 06601-1381

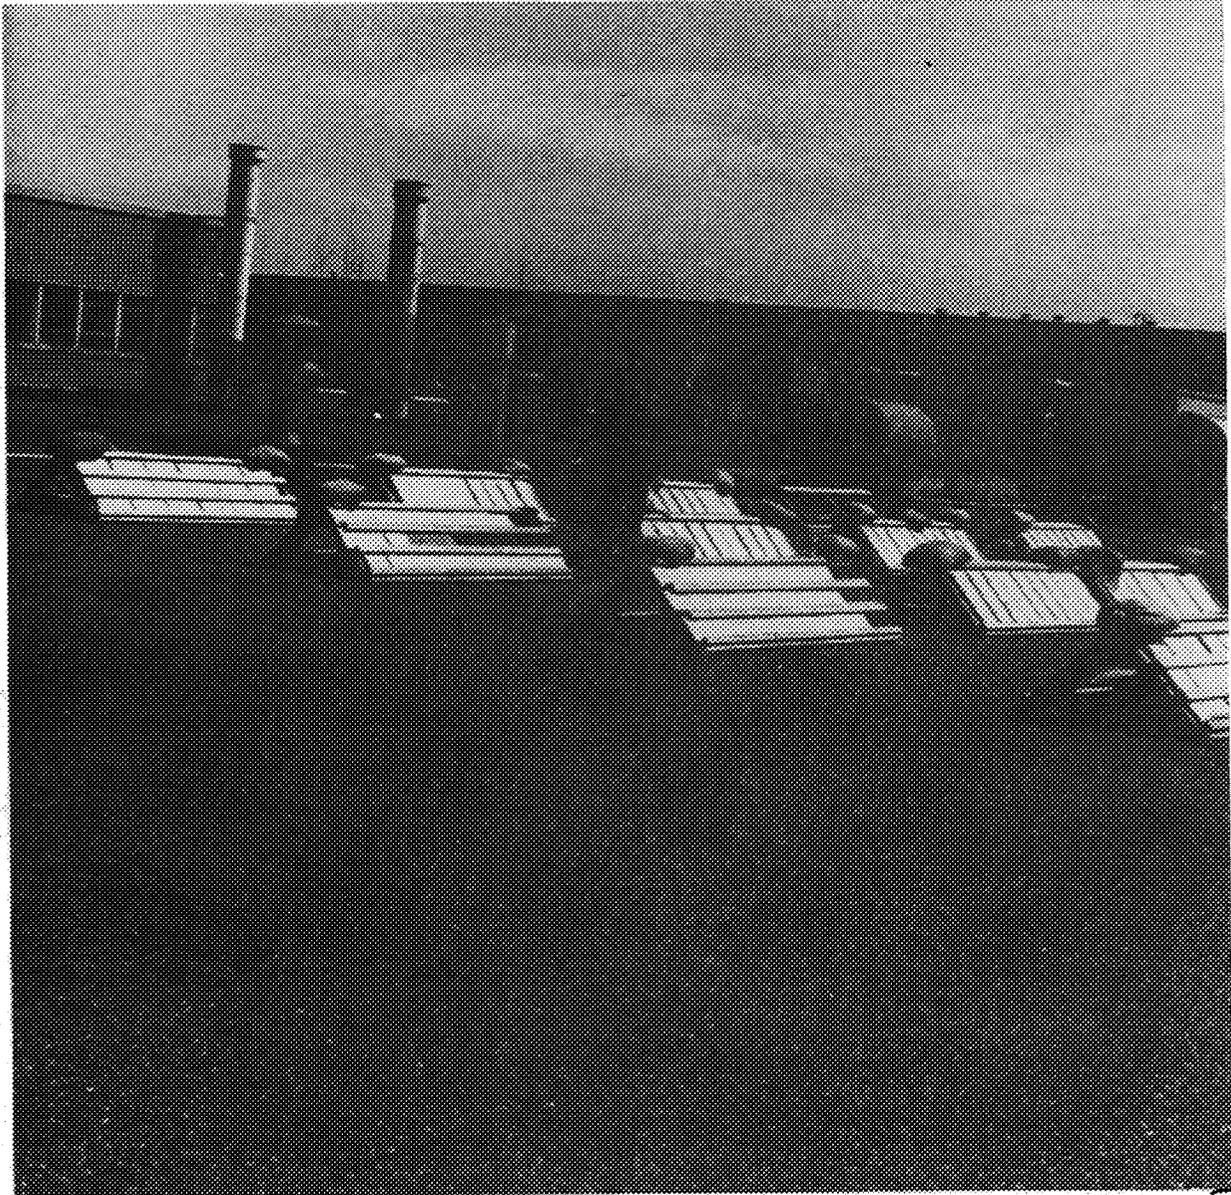
FIGURE 46. PANELS DEPLOYED FOR ENVIRONMENTAL EXPOSURE
AT THE STRATFORD, CONNECTICUT EXPOSURE SITE
